NASA Technical Paper 2406

High-Temperature Erosion of Plasma-Sprayed, Yttria-Stabilized Zirconia in a Simulated Turbine Environment

Propulsion Laboratory
USAAVSCOM Research and Technology Laboratories
Lewis Research Center
Cleveland, Ohio

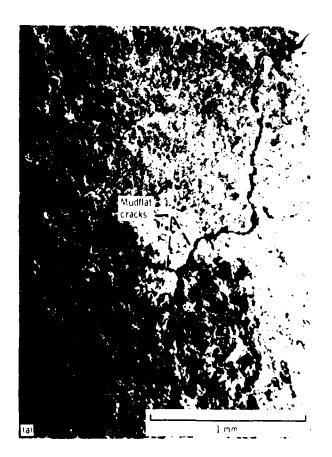
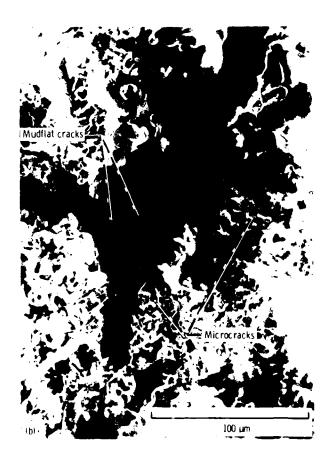
Figure 14. -- Specimen 9a after rig test without erosive particles in flow, showing mudflat cracks and microcracking of YSZ

The first specimen to be discussed is one in which a series of preliminary surface temperature measurements were made. This particular specimen was not eroded but instead was thermally cycled at a number of downstream positions and perpendicular (90° impingement) to the gas flow. The plasma-sprayed surface (fig. 14) showed microcracking from the plasma spray process along with mudflat cracking due to thermal stress relaxation.

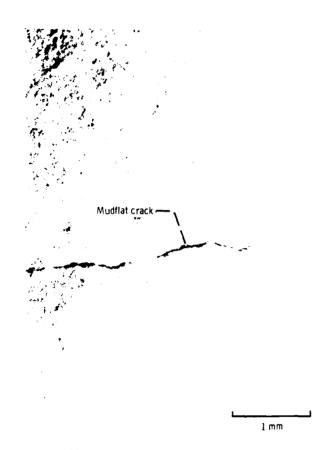
Figure 16.—SEM photograph showing preferential erosion in zone near mudflat crack. Specimen eroded at 12.7-cm (5-in.) downstream distance and 90° impingement angle.
